# Healthcare Logistics

## Property Services

**Project**  
Industrial

**Location**  
58 Richard Pearse Drive  
Mangere, Auckland

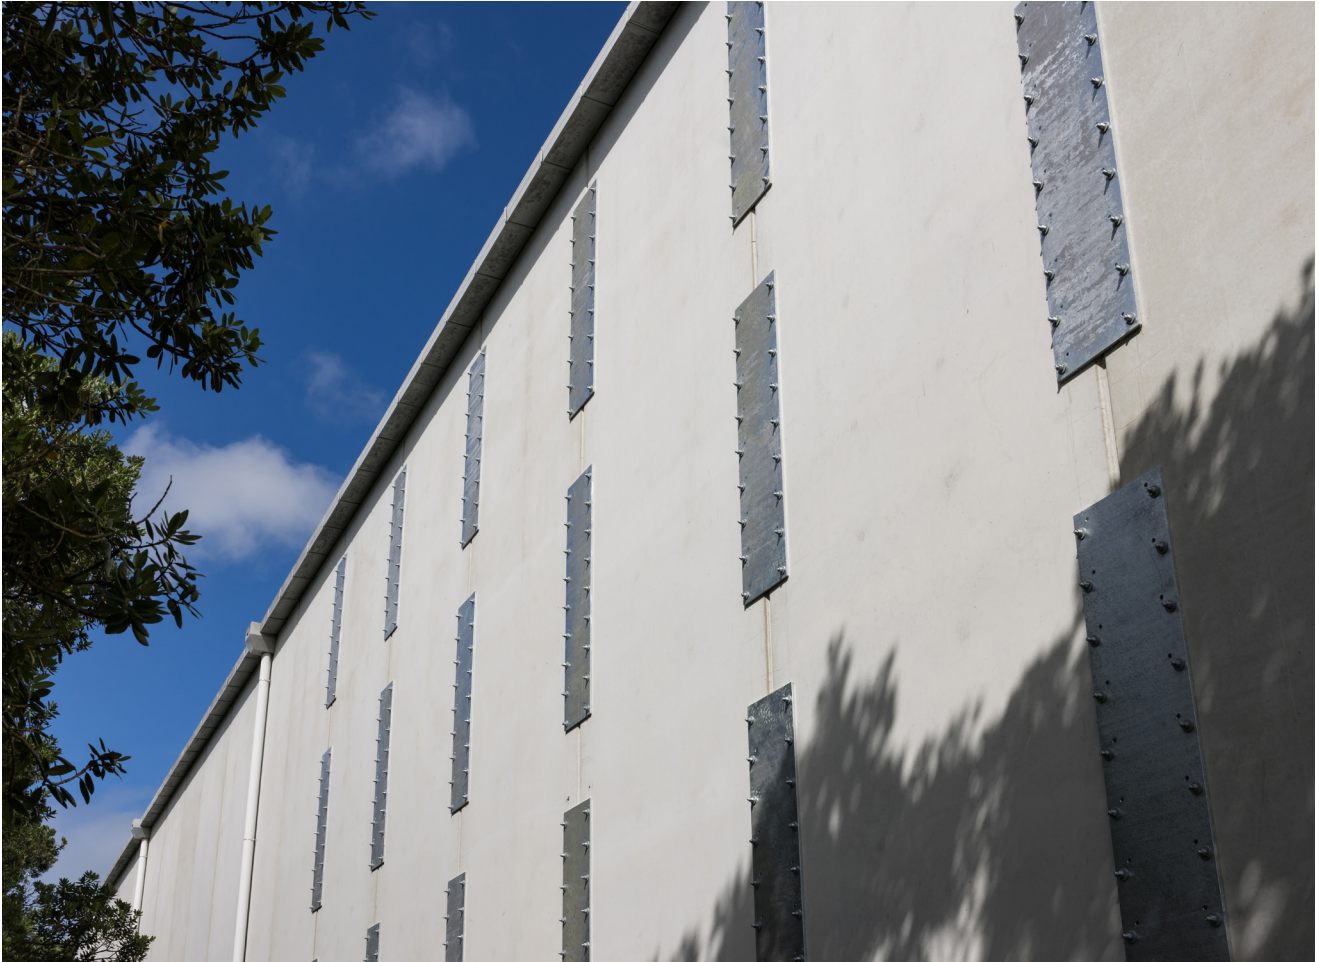
This was a seismic strengthening exercise on a commercial property near Auckland Airport. With the tenant not keen on major works inside the building, the solution involved bolting 2.2 x 1 metre galvanised plates to the exterior of the precast concrete panels, effectively locking everything together. (Plates were also used internally at the four corners.) Because this was a live site, it was a priority to try to keep the tenants informed and happy.
